**RE: 20525 AND 20541 46A AVENUE, LANGLEY – ENVIRONMENTAL  
OVERVIEW ASSESSMENT REPORT**

ENKON File No. 1988-001

## INTRODUCTION

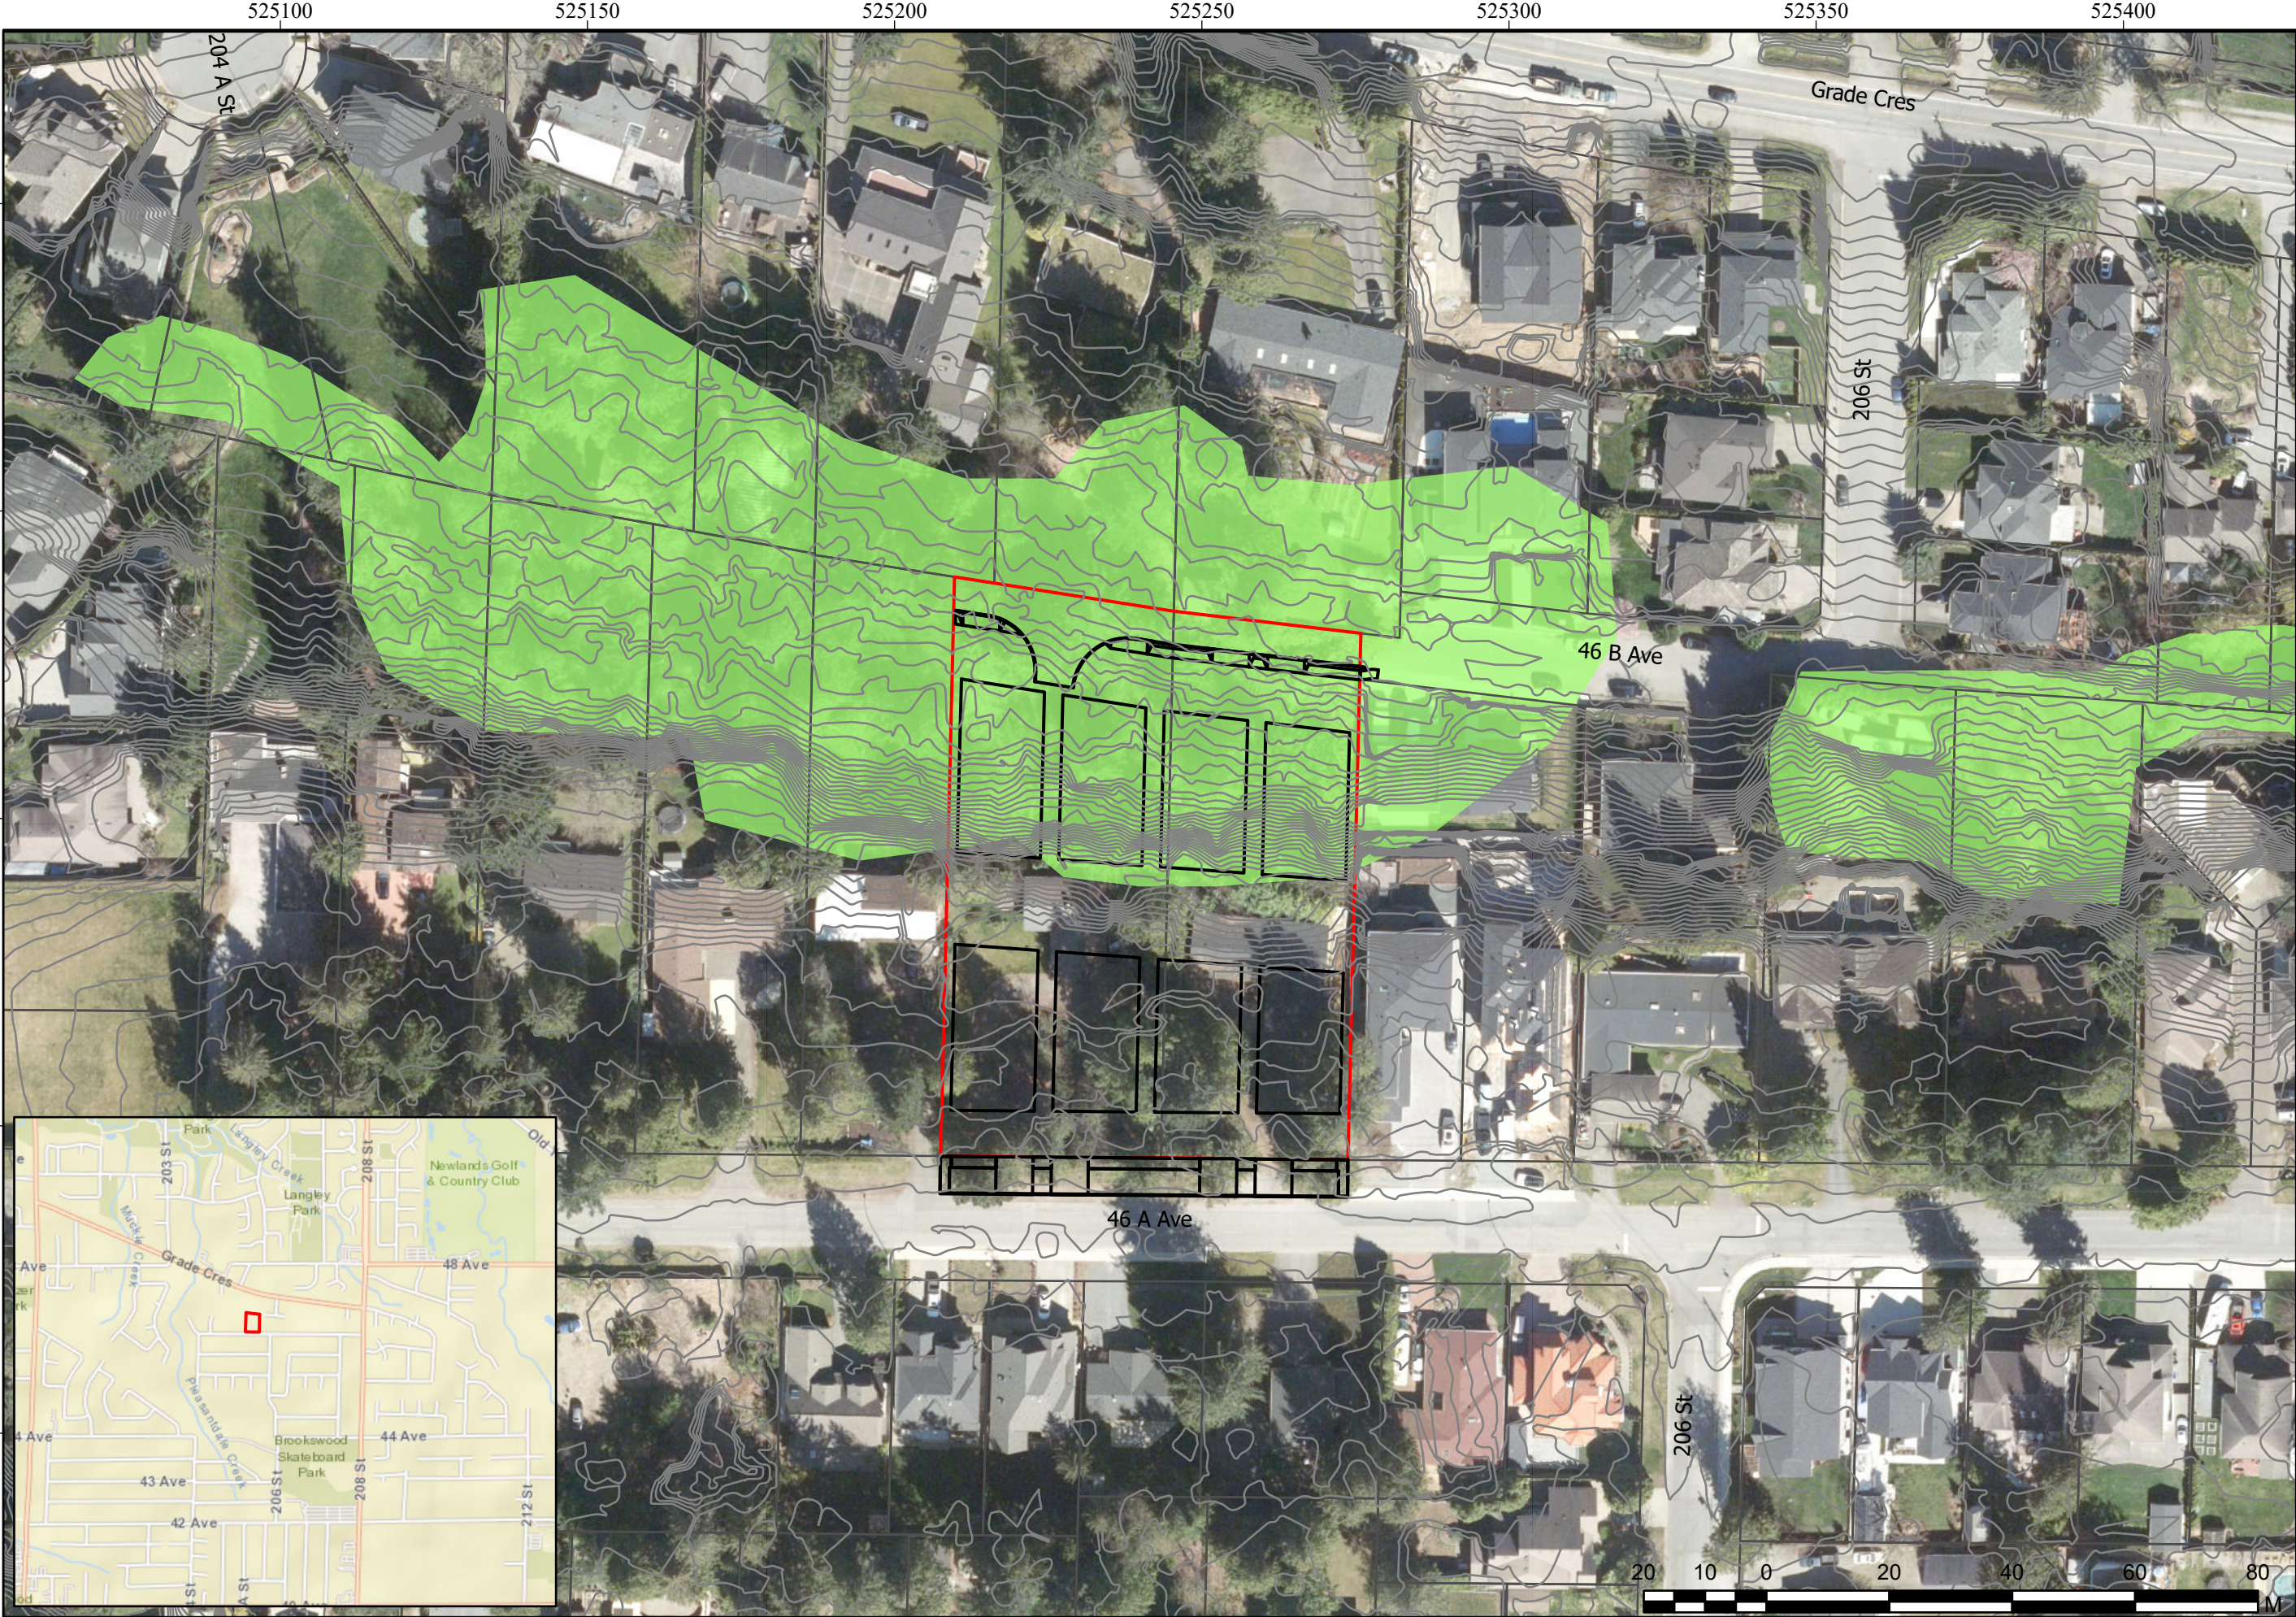
Figure 1

The Property includes a portion of an isolated Environmentally Sensitive Area ranked as moderately low value (Figure 1).

# Site Plan

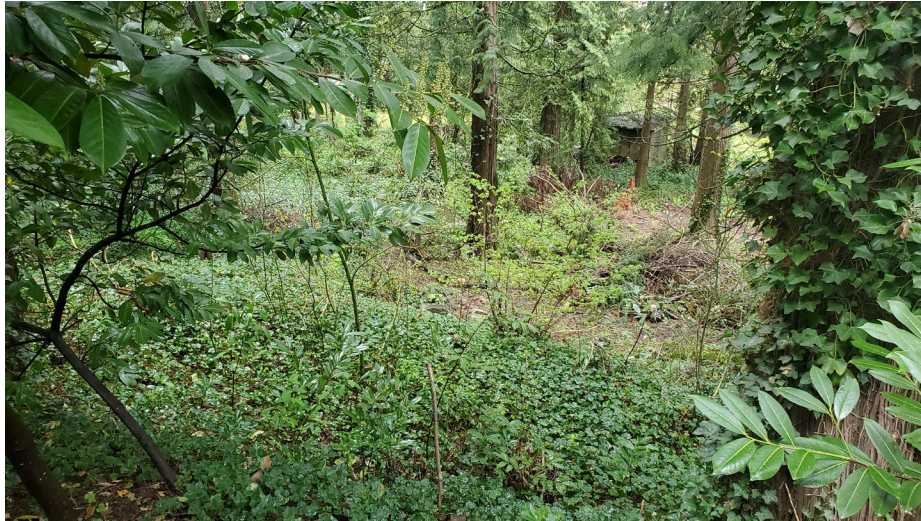
The Property has deciduous and coniferous trees, confined primarily to the ESA portion of the Property, below a steep slope break in the Property. The southern portion of the Property consists of a recently demolished house, as well as landscaped yard. Vegetation within the ESA was dominated by western redcedar (*Thuja plicata*) and vine maple (*Acer circinatum*) with several invasive species in the understory, including English ivy (*Hedera helix*), Himalayan blackberry (*Rubus armeniacus*), and English laurel (*Prunus laurocerasus*) (Photograph 1). There is an existing shed located within the ESA (Photograph 2).

**Photograph 1:** Looking north into the ESA (April 25, 2022).

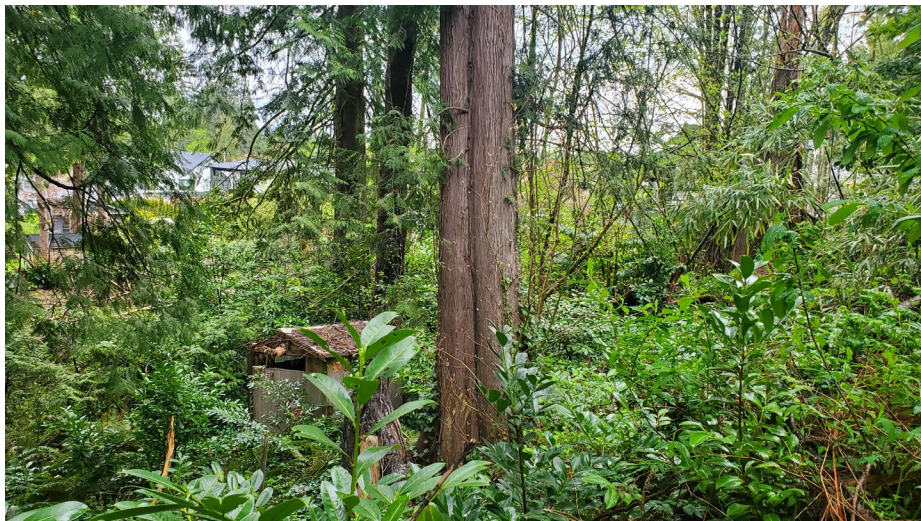
**Photograph 2:** Looking northeast into the ESA showing existing shed (April 25, 2022).

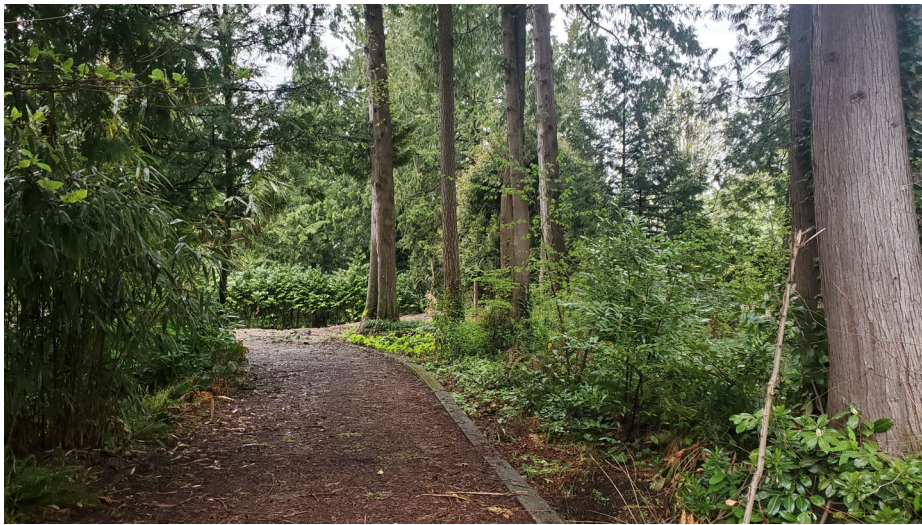
The southern half of the Property, where the previous building sites were located, is dominated by mature coniferous trees, including western redcedar and Douglas-fir (*Pseudotsuga menziesii*), with several non-native ornamental and invasive species in the understory, including rhododendron, English laurel, bamboo, English ivy, and periwinkle (*Vinca* sp.) (Photographs 3 to 5).

**Photograph 3:** Looking north along the driveway of 20525 46A Avenue (April 25, 2022).

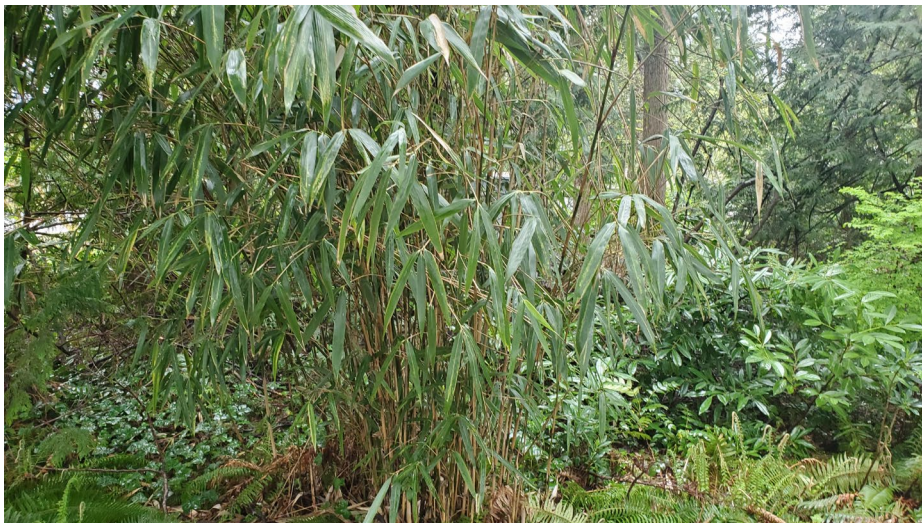
**Photograph 4:** Non-native species in previous residential yard in southern portion of the Property (April 25, 2022).

To avoid impacts to nesting birds and contravention of the federal *Migratory Bird Conventions Act* and Section 34b of the *BC Wildlife Act*, vegetation clearing should be scheduled outside of the nesting period (generally March 1 through August 31). If clearing outside of this period cannot be avoided, an active bird nest survey should be completed.

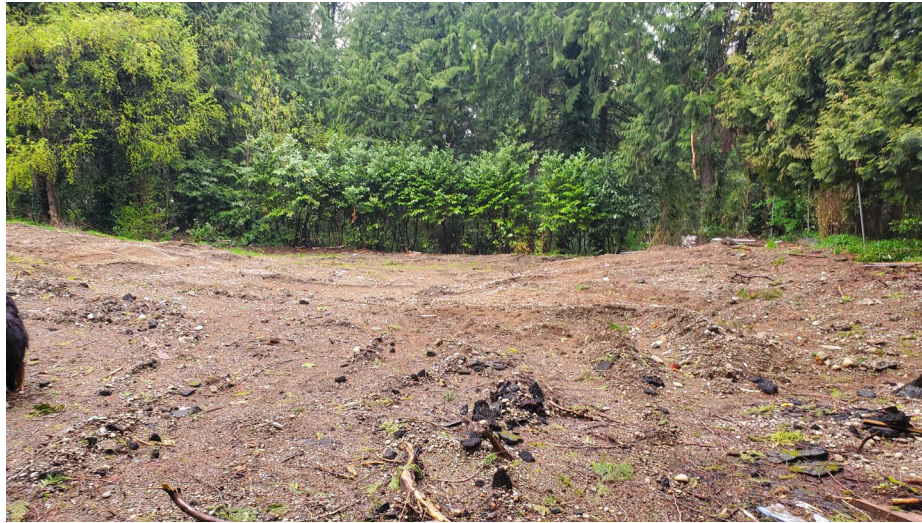
**Photograph 5:** Looking north at previous building site at 20525 46A Avenue (April 25, 2022).

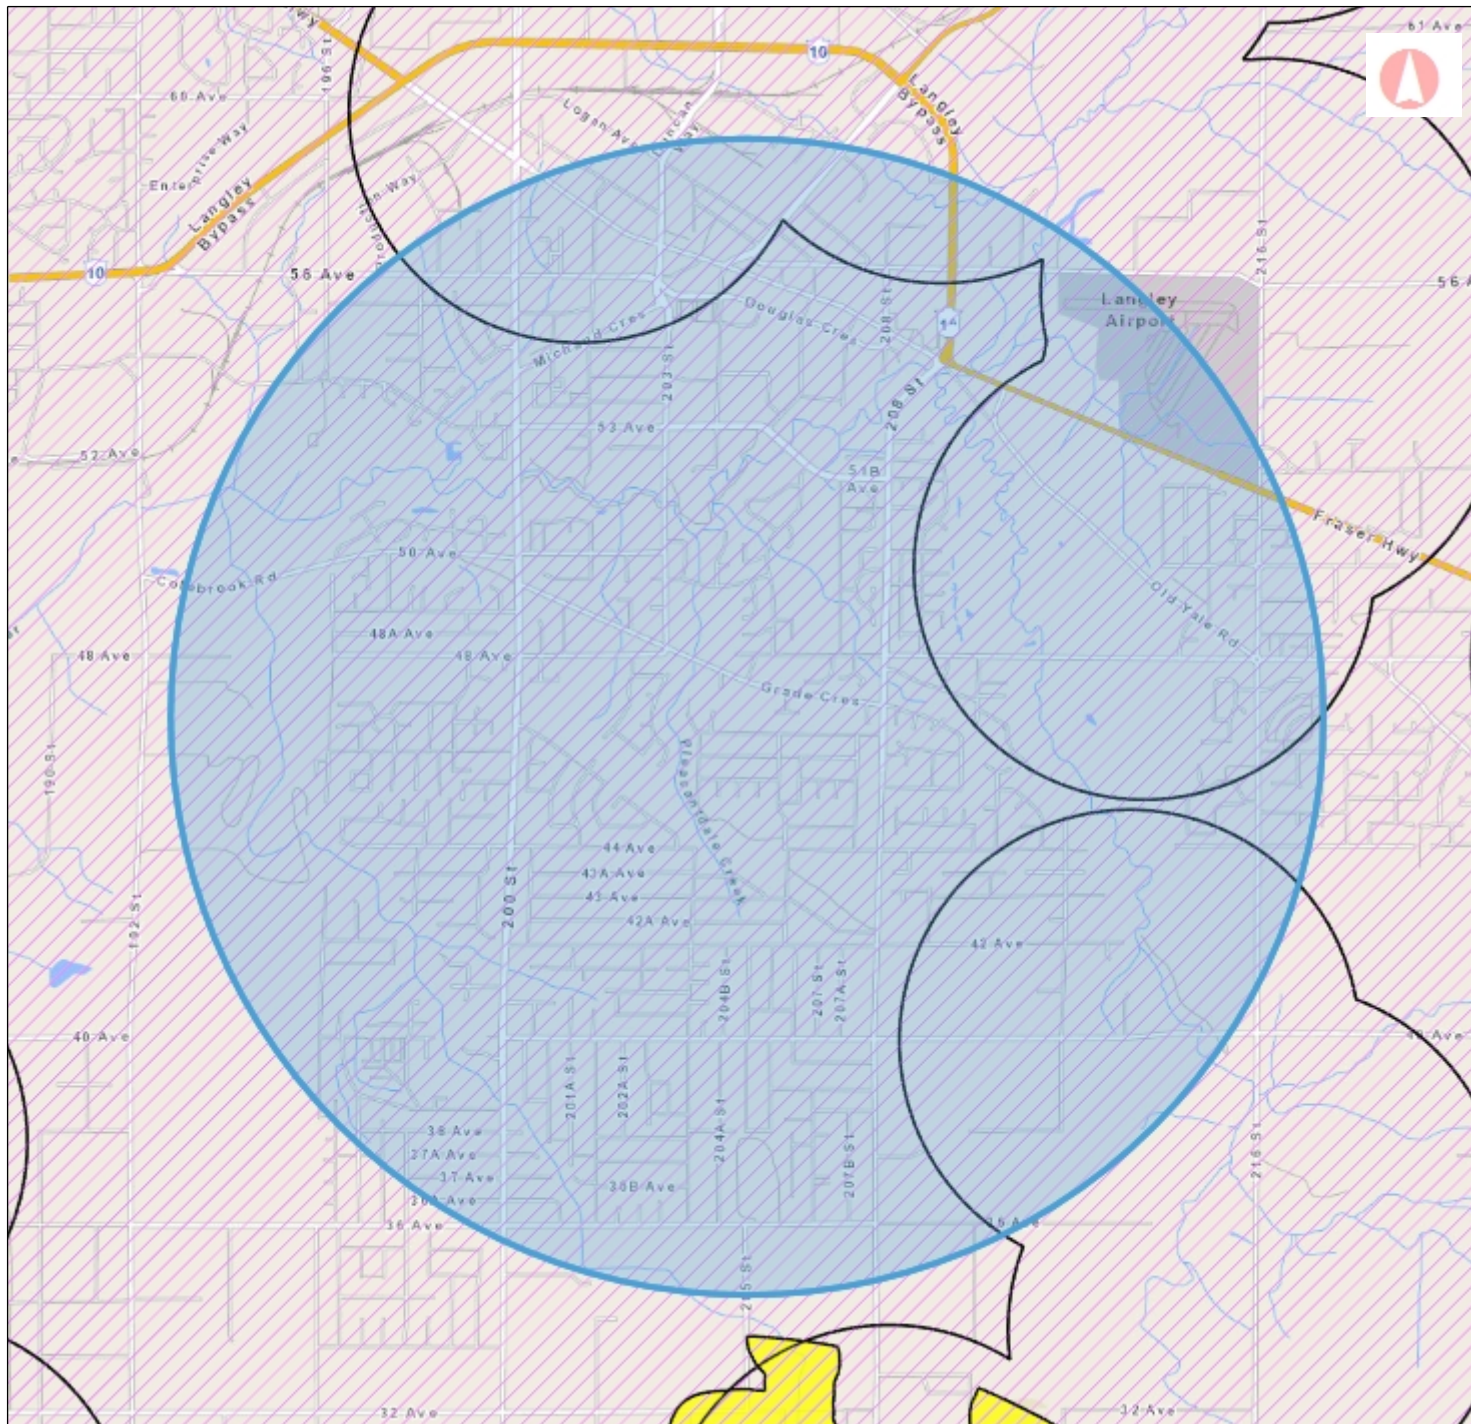
## Critical Habitat

A map of the critical habitat located within 2.5 km of the Property is provided in Appendix A. Proposed critical habitat for marbled murrelet (*Brachyramphus marmoratus*), which includes the entirety of the southern mainland coast of BC, intersects the Property. There is also proposed critical habitat for barn owl (*Tyto alba*) within 2.5 km of the Property.

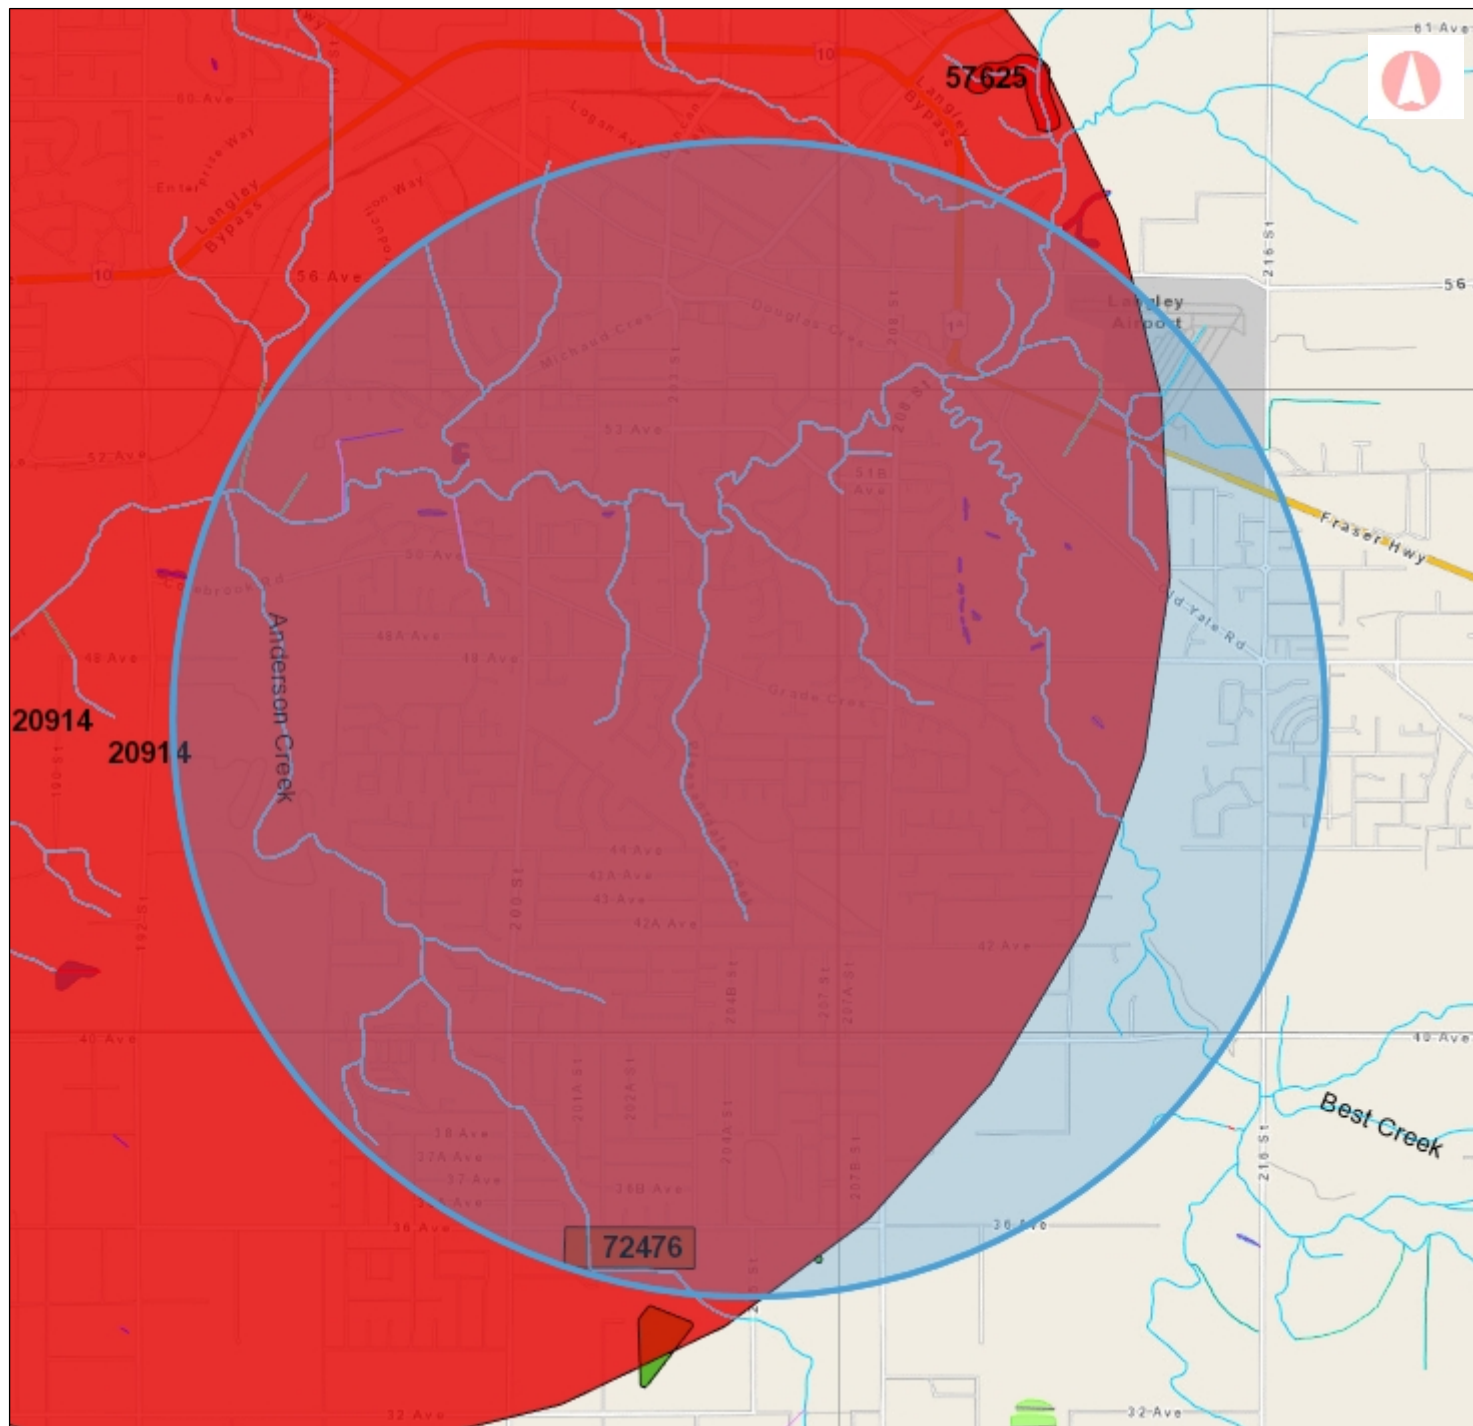
## Rare Element Occurrence Records Legend

A map of element occurrences documented by the CDC within 2.5 km of the Property is presented in Appendix A. Two element occurrences have been documented by the CDC within 2.5 km of the Property:

- Vancouver Island beggarticks (*Allogona townsendiana*) (Shape ID 72476) –more than 2 km south of the Property; and
- Mountain beaver (*Aplodontia rufa*) (Shape ID 20914) – historical record from 1969 precise location unknown. Does overlap with the Property.
